UNITED STATES DEPARTMENT OF AGRICULTURE
Soil Conservation Service
H. H. Bennett, Chief

Investigations Pertaining to Run-off from Farm Land
in Murray County, Minnesota

C. E. Ramser, Research Specialist in Hydrology

Originally Prepared in 1920
Slightly Revised February 1946

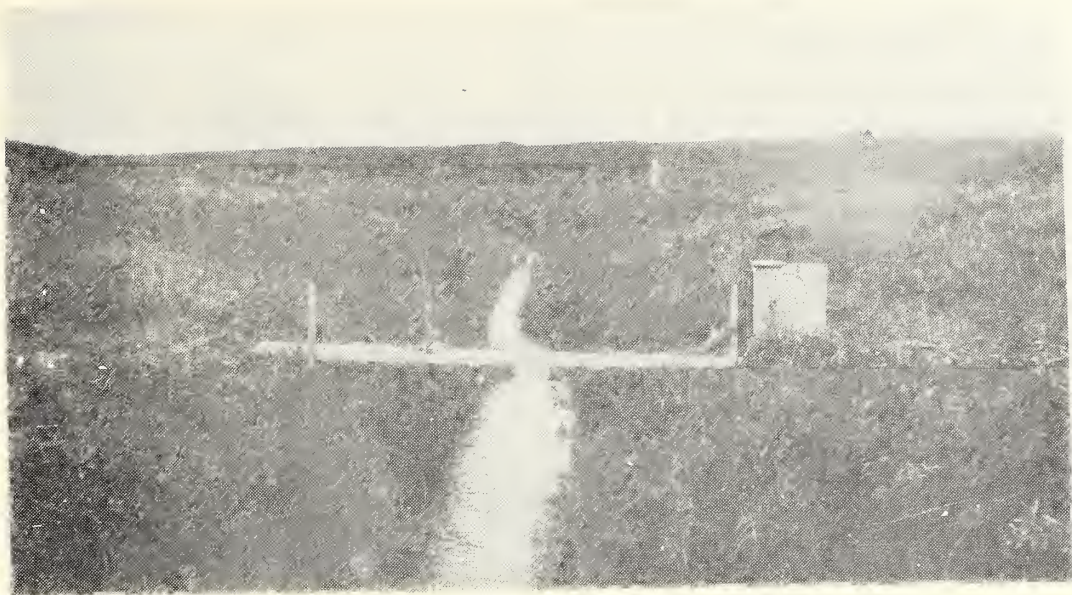
Plate I, Figure 1.--Gaging station on open ditch
below tile outlet of County Ditch No. 47 showing
footbridge staff gage and pressure gage box.

Gagings of the flow from the tile were made from a foot bridge over the open ditch about 50 feet below the tile outlet. Views of the bridge and the outlet are shown in pl. 1, figs. 1 and 2. Fluctuations of the water surface were recorded by means of a pressure gage (Sanborn recorder) so that a continuous record of the water stages was obtained. In figures 7 to 11 are shown continuous hydrographs of the runoff in inches per 24 hours for storms during the period of these investigations. During the first part of the rains a heavy surface runoff generally occurred and these hydrographs include both surface and tile runoff.

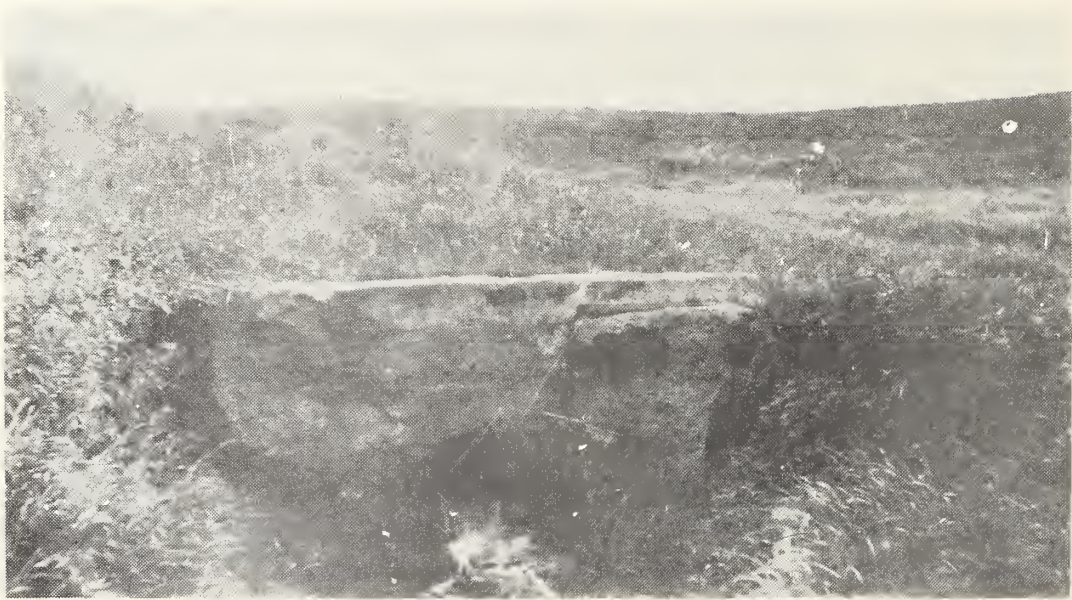
Plate I, Figure 2.--Sixteen inch tile outlet,
County Ditch No. 47

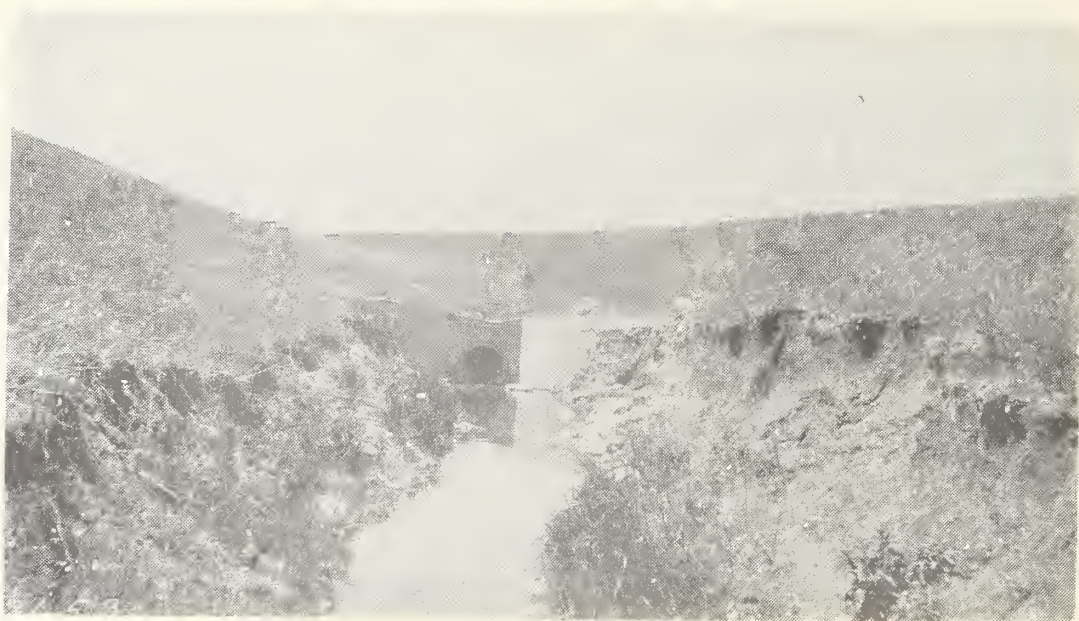
Plate II, Figure 2.--Thirty inch tile outlet, Judicial
Ditch No. 15

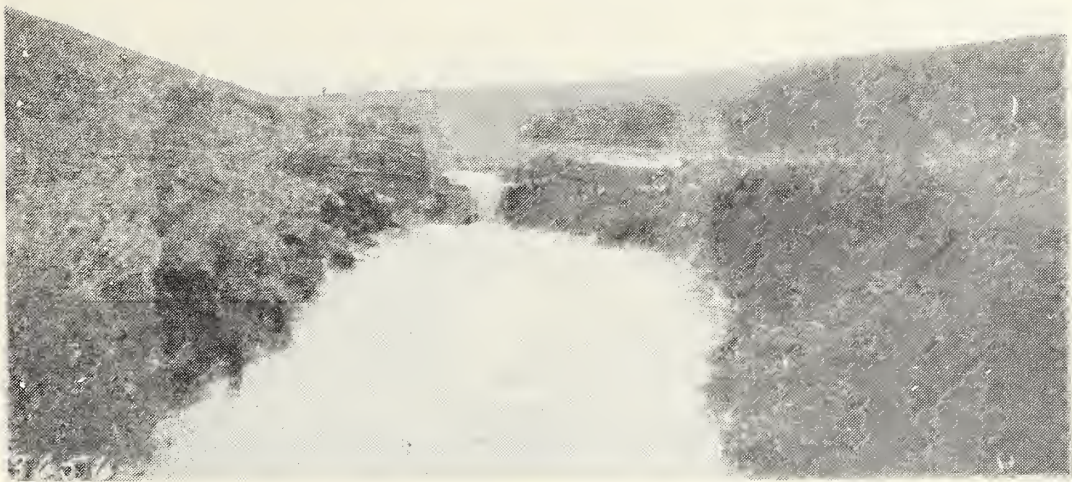
Plate III. Figure 1.--Surface water flowing over headwall at tile outlet, Judicial Ditch No. 15

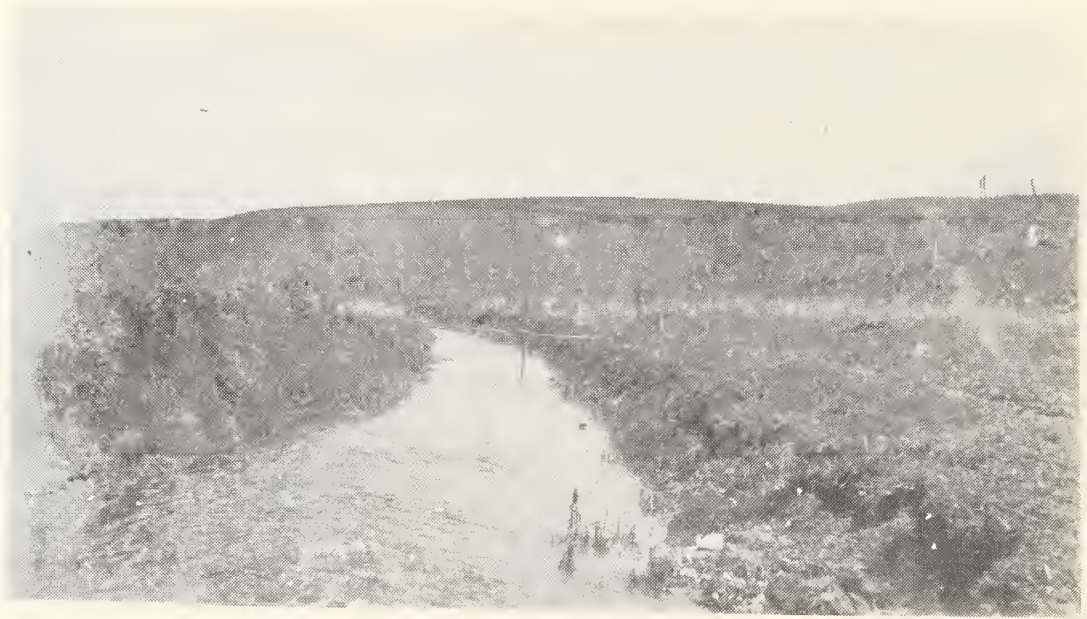
Plate IV, Figure 1.—Gaging station and upper end of slope course of
Judicial Ditch No. 15

A course of channel 220 feet in length with an easy curve was selected just below the outlet end of a 30-inch tile. Gagings were made near the upper end of the course from a footbridge shown in plate IV, figure 1.
